Access Statement – Charing Cross (16.10.09)

Charing Cross
The Strand
London WC2N 5HX

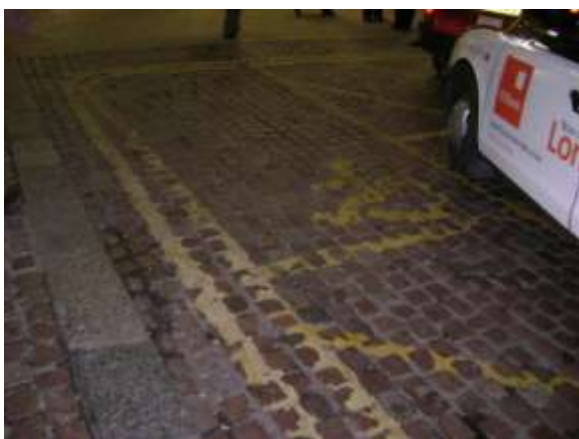
There are designated bays at the Trafalgar / Spring Gardens car park, but for those with a higher roofed or adapted vehicle, this multi-storey car park has a **height restriction of 6'5"** (1.95m).

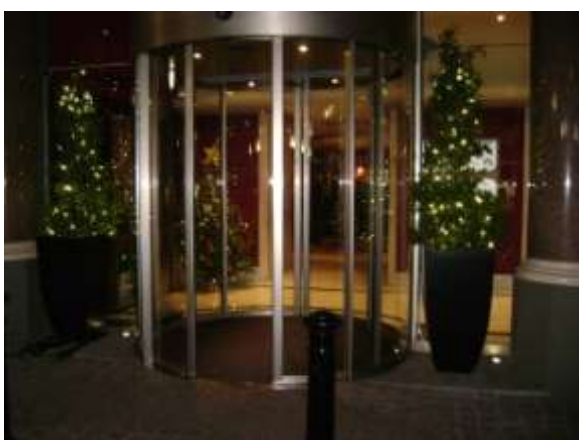
The main entrance to the hotel is wheelchair accessible at street level. There are automatic curved sliding doors leading directly to reception on the ground floor.

The doors are 1450mm minimum clear opening. There is also a side hung door 940mm clear opening if required.

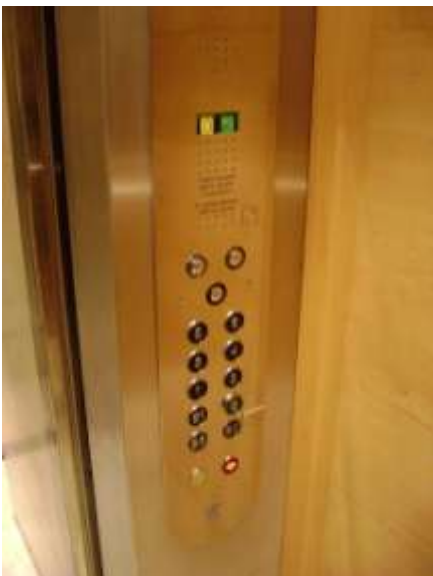
There are 2 guest lifts from the ground floor to the public areas and bedroom floors. These have automatic sliding doors that are 880mm clear opening that are fitted with sensors. The clear floorspace in these lifts is 1650x1270mm minimum. Lift controls are a maximum of 1170mm high and have tactile buttons. There is both visual and audible floor announcement in the lifts. A symbol suggests that the emergency communication point is fitted with an inductive coupler for hearing aid users. The lifts are fitted with a handrail and a mirror on the rear wall.

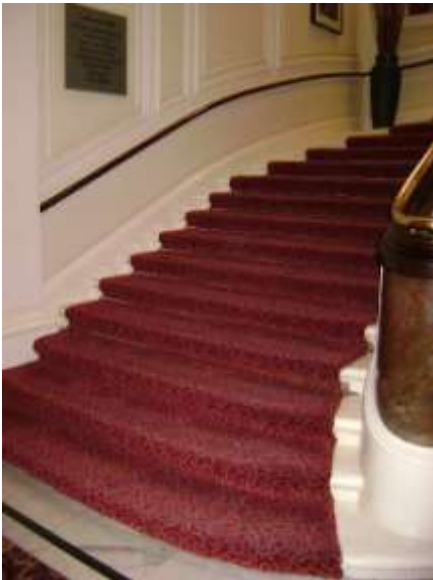
There is also a sweeping staircase (pictured) from the ground to the 1st floor, with 43 steps (and no resting places or landings). This is accompanied by a wooden handrail to one side and a metal handrail to the other.

There are a further 32 steps (9 + 14 + 9) from the 1st floor to the bedrooms on the 2nd floor (with 2 landings).

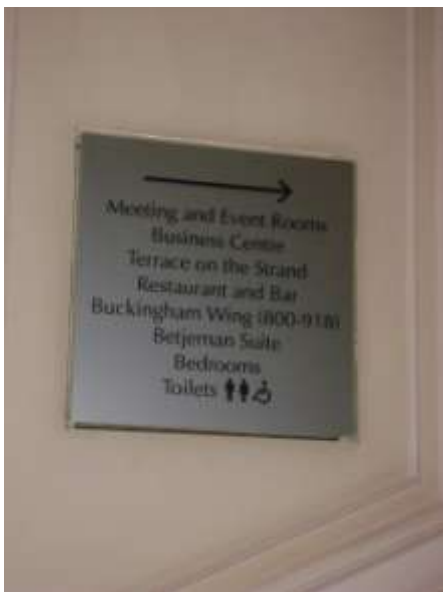
Terrace on the Strand Restaurant & Bar:

The restaurant has double doors which are open (1200mm minimum) when operating.

There is seating with and without armrests, and the tables have clear space beneath them of at least 700mm. Staff will provide assistance to those who need it.

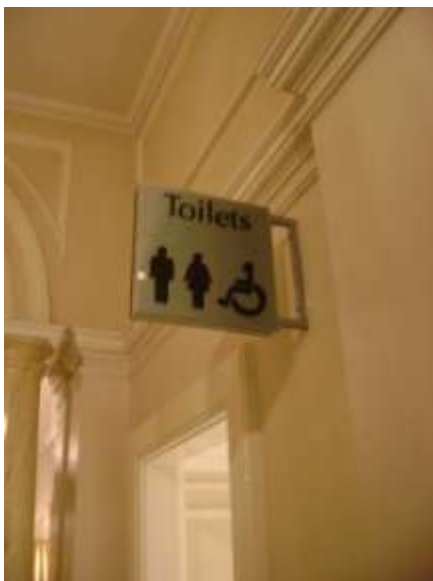
Public WCs – including a designated accessible WC are on the 1st floor - the same level as the main public areas. The WCs are situated opposite the Watergate meeting room, about 30m from the bar and restaurant.

The door to the designated accessible WC is 830mm clear opening, is fitted with a door bar to aid closure, and a flip over style lock. The door opens outwards, and there is 2200mm clear space opposite the door.

There is clear floorspace in the room of 1200x1200mm minimum. The floor surface is ceramic tiles.

Currently, there is no flashing light linked to the fire alarm system.

There is a vertical rail beside the hand basin.

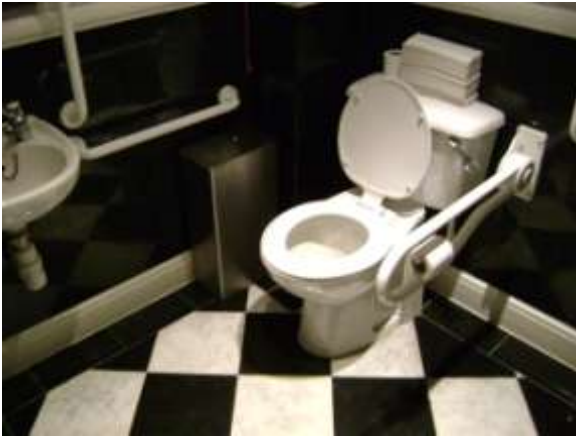
There is a fold down rail on the transfer side and a horizontal and vertical rail opposite the transfer space – currently the horizontal fixed rail may be slightly too far from the pan for some users.

There is lateral (sideways) transfer to the WC of 1000mm to the right. The height of the WC seat is 460mm.

There is an emergency cord in the room beside the WC that is linked to reception.

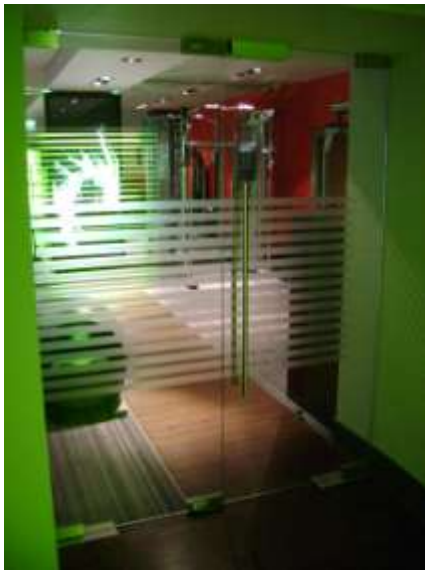
There is a Gym situated on Basement Level 2 (accessed via the lift) but it is not supervised. There are no steps on route. Guests wishing to use the facilities must complete a disclaimer. Doors on route are retained open by Dorgard system.

The door to the Gym is 730mm clear opening, with 2600mm opposite the door. There is clear floorspace in the room of 3000x2000mm minimum. There are 2 x upper body exercise machines. There are no changing facilities associated with the room. The nearest designated accessible WC is on the 1st floor via the lift.

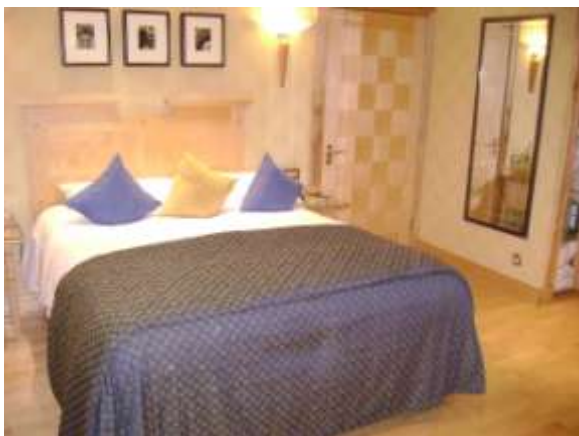
There are 239 rooms at this hotel, 2 of which are designated for disabled guests, on the 2nd floor. Both have wooden surfaced floors and a wheel-in shower. Rooms are fitted with an emergency button beside the bed. Currently there is no emergency beacon linked to the hotel fire alarm system. Room 210 is the largest and 207 (pictured) is slightly smaller (both have adjoining rooms).

The doors to the rooms are 855mm clear opening, and are situated on corridors that are at least 1770mm wide.

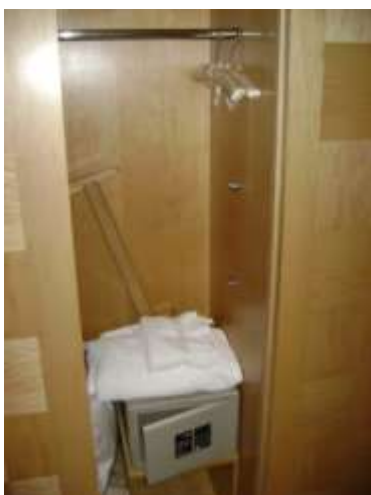
The doors to interconnecting rooms are 850mm clear opening.

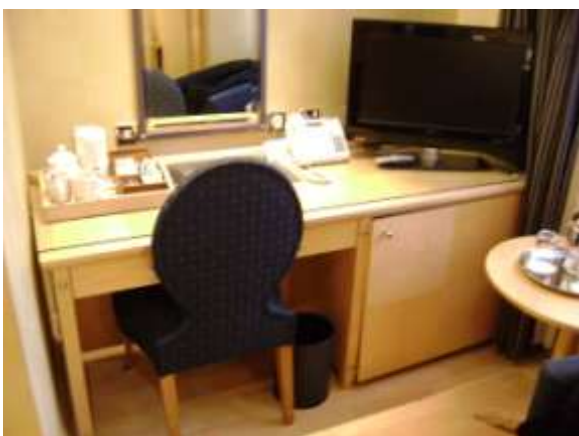
There is clear floorspace in the rooms from 1900x1500mm minimum, with clear space of at least 900mm (room 210) up to 1500mm to one side of the bed (room 207).

The beds are currently 670mm high to the top of the mattress. There is no space currently under the beds for a mobile hoist.

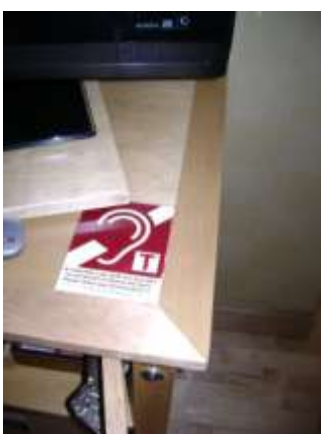
There is clear space under the desk of just **605mm**.

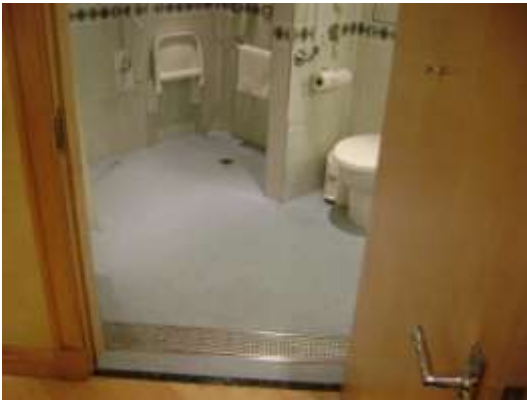
The doors to shower rooms are 870mm clear opening outwards into the bedrooms, with a minimum of 1500mm clear space opposite the door.

Currently there is no horizontal rail to enable closure of the door from inside the room.

There is clear floorspace of 1700x1600mm minimum within these rooms, plus additional space in the shower area.

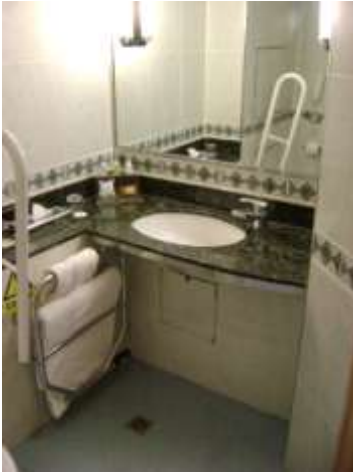
Basins have lever operated mixer taps. There is space beneath the basins of up to 700mm, but currently some users may find difficulty with getting close to the basins because the service area beneath has been tiled in. There is currently no vertical rail beside the hand basin.

Care should be taken around the radiators– which can be switched off.

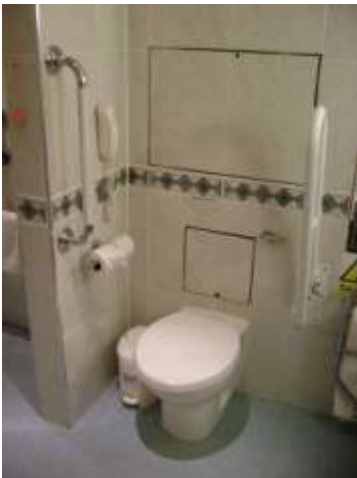
WCs are **410 - 430mm** high and have one horizontal rail room 210 (or **vertical rail room 207**) for aiding transfer to the WC seat.

Both WCs have a fold down rail on the transfer side. There is angled transfer of up to 800mm the right to the WC in room 207 (pictured), and 1000mm to the left in room 210.

Showers have a fold down shower seat 440mm high. The seat size is 300mm deep x 400mm wide. There is a horizontal rail in the shower area (which may be too far forward in room 210), plus a fold down rail on the transfer side of the seat. The water temperature is thermostatically controlled. There is clear space of 1000mm minimum beside shower seats.

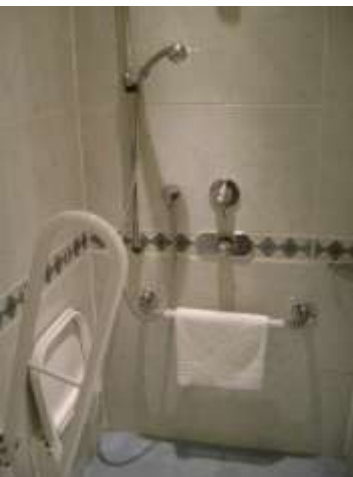
Currently there is no light linked to the fire alarm system in the shower rooms.

Floor surfaces are designed to be non-slip.
